EG&G ROCKY FLATS
ENVIRONMENTAL MANAGEMENT DEPARTMENT
ASSESSMENT OF KNOWN, SUSPECT, AND POTENTIAL
ENVIRONMENTAL RELEASES OF
POLYCHLORINATED BIPHENYLS (PCBs)

PRELIMINARY ASSESSMENT/SITE DESCRIPTION

October 1991

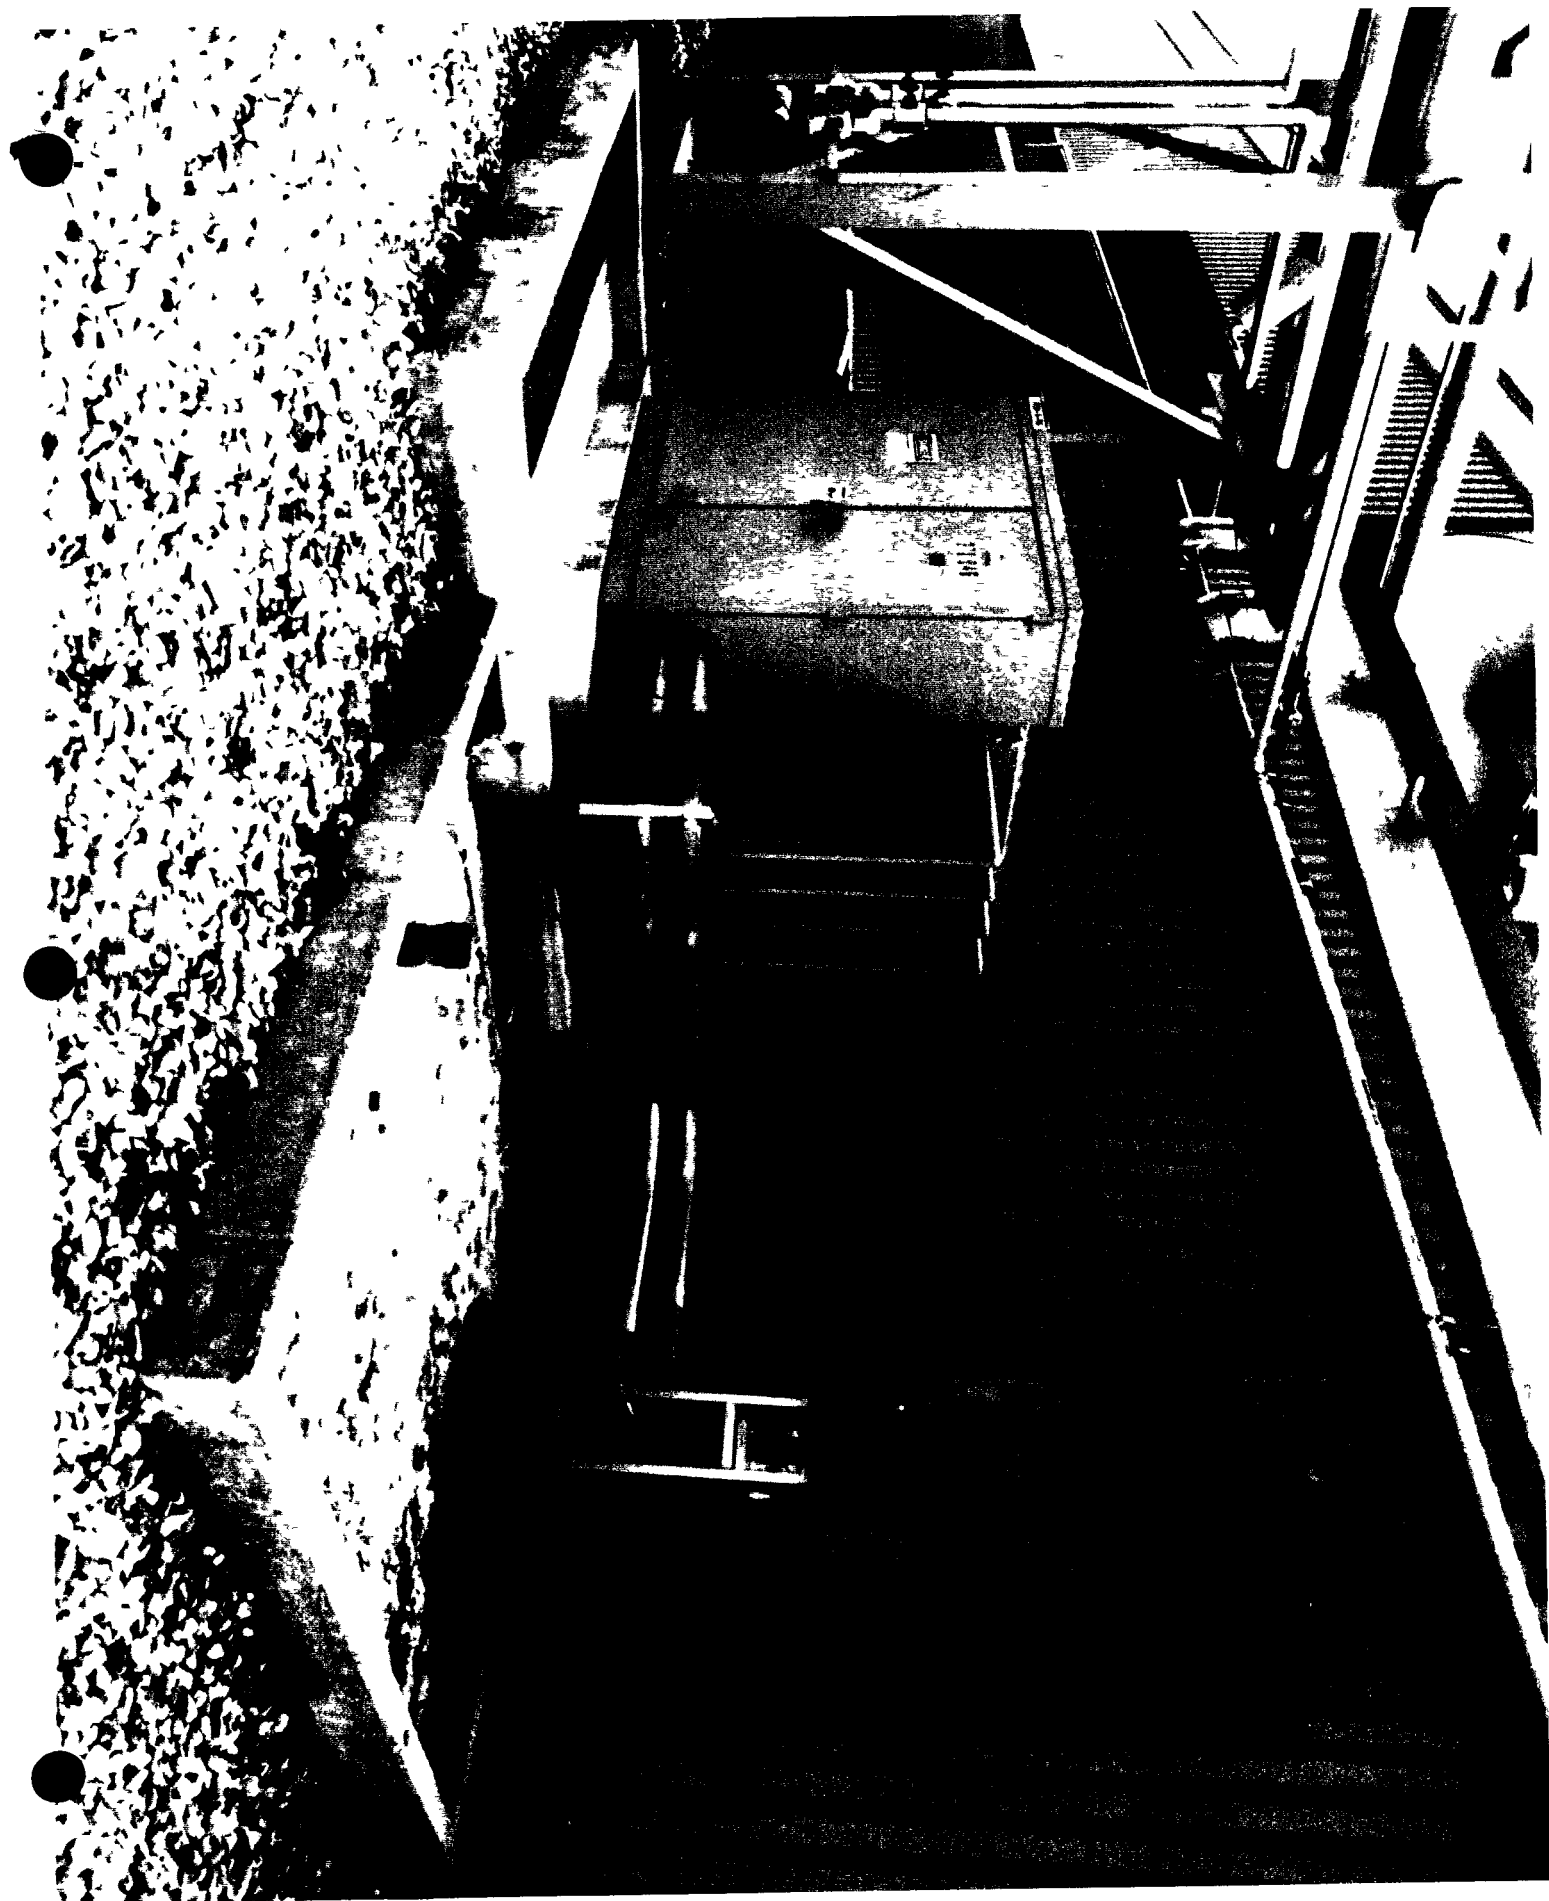
SITE #23 - Adjacent to Building 559

Transformer 559-1 located at this site (Photo 23) reportedly leaked oil containing PCBs from a faulty valve prior to being removed and retro-filled in 1987 according to an interview with Utilities personnel. The transformer has since been placed on a new pad several feet south of the previous location. This site is located adjacent to the east wall of building 559 as well as IHSS 159 and approximately 30 feet west of IHSSs 150 2 and 162. A cracked berm is in the location of the old pad. It is not known if it was cracked at the time the transformer reportedly leaked. Concrete material was removed from the old pad. The disposition of concrete material is not known at this time, and consequently, the fate of the constituents from the concrete material. An effort is being pursued to locate this information. Rock fill currently covers the area of both pads.

Site #23 is prioritized as a category II

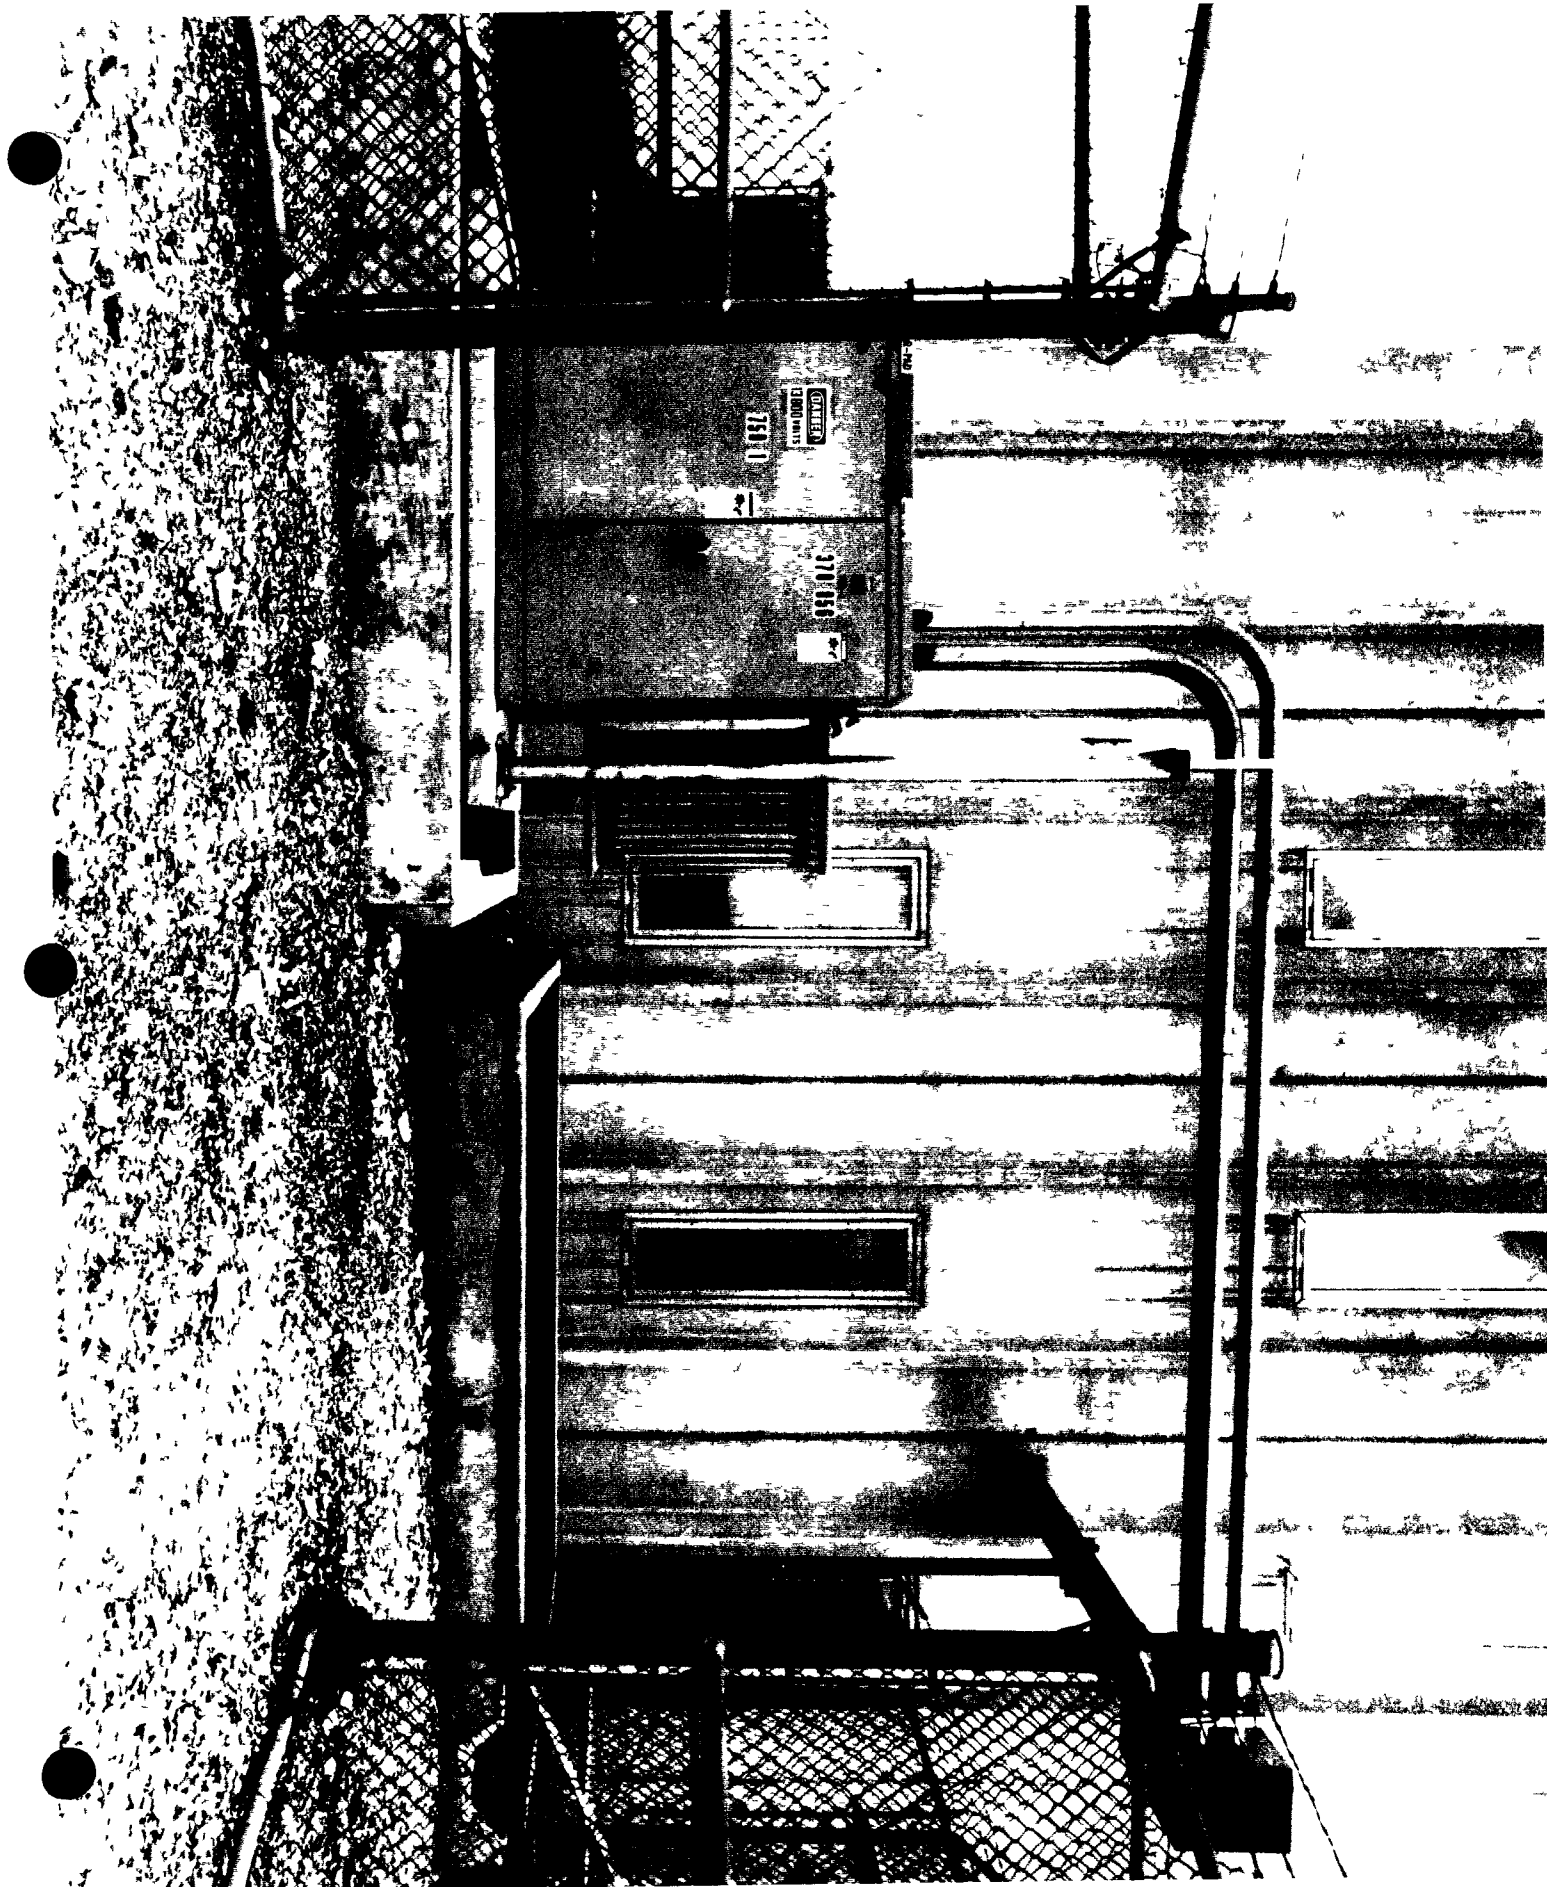
SITE #26 - North of Building 750

Documentation in plant files indicates that the transformer (750-1) at this location (Photo #26) leaked oil containing PCBs prior to being relocated and retro-filled in 1987 according to interviews with Utilities personnel. The old transformer is now located on a new pad several feet east of its previous location. There are berms around the site with no fill. There are no drains in the vicinity of the site. This area is 5 feet north of building 750 and is located in IHSS 150 4, 100 feet west of IHSS 214 and 70 feet south of IHSS 150 6.

Site #26 is prioritized as a Category II

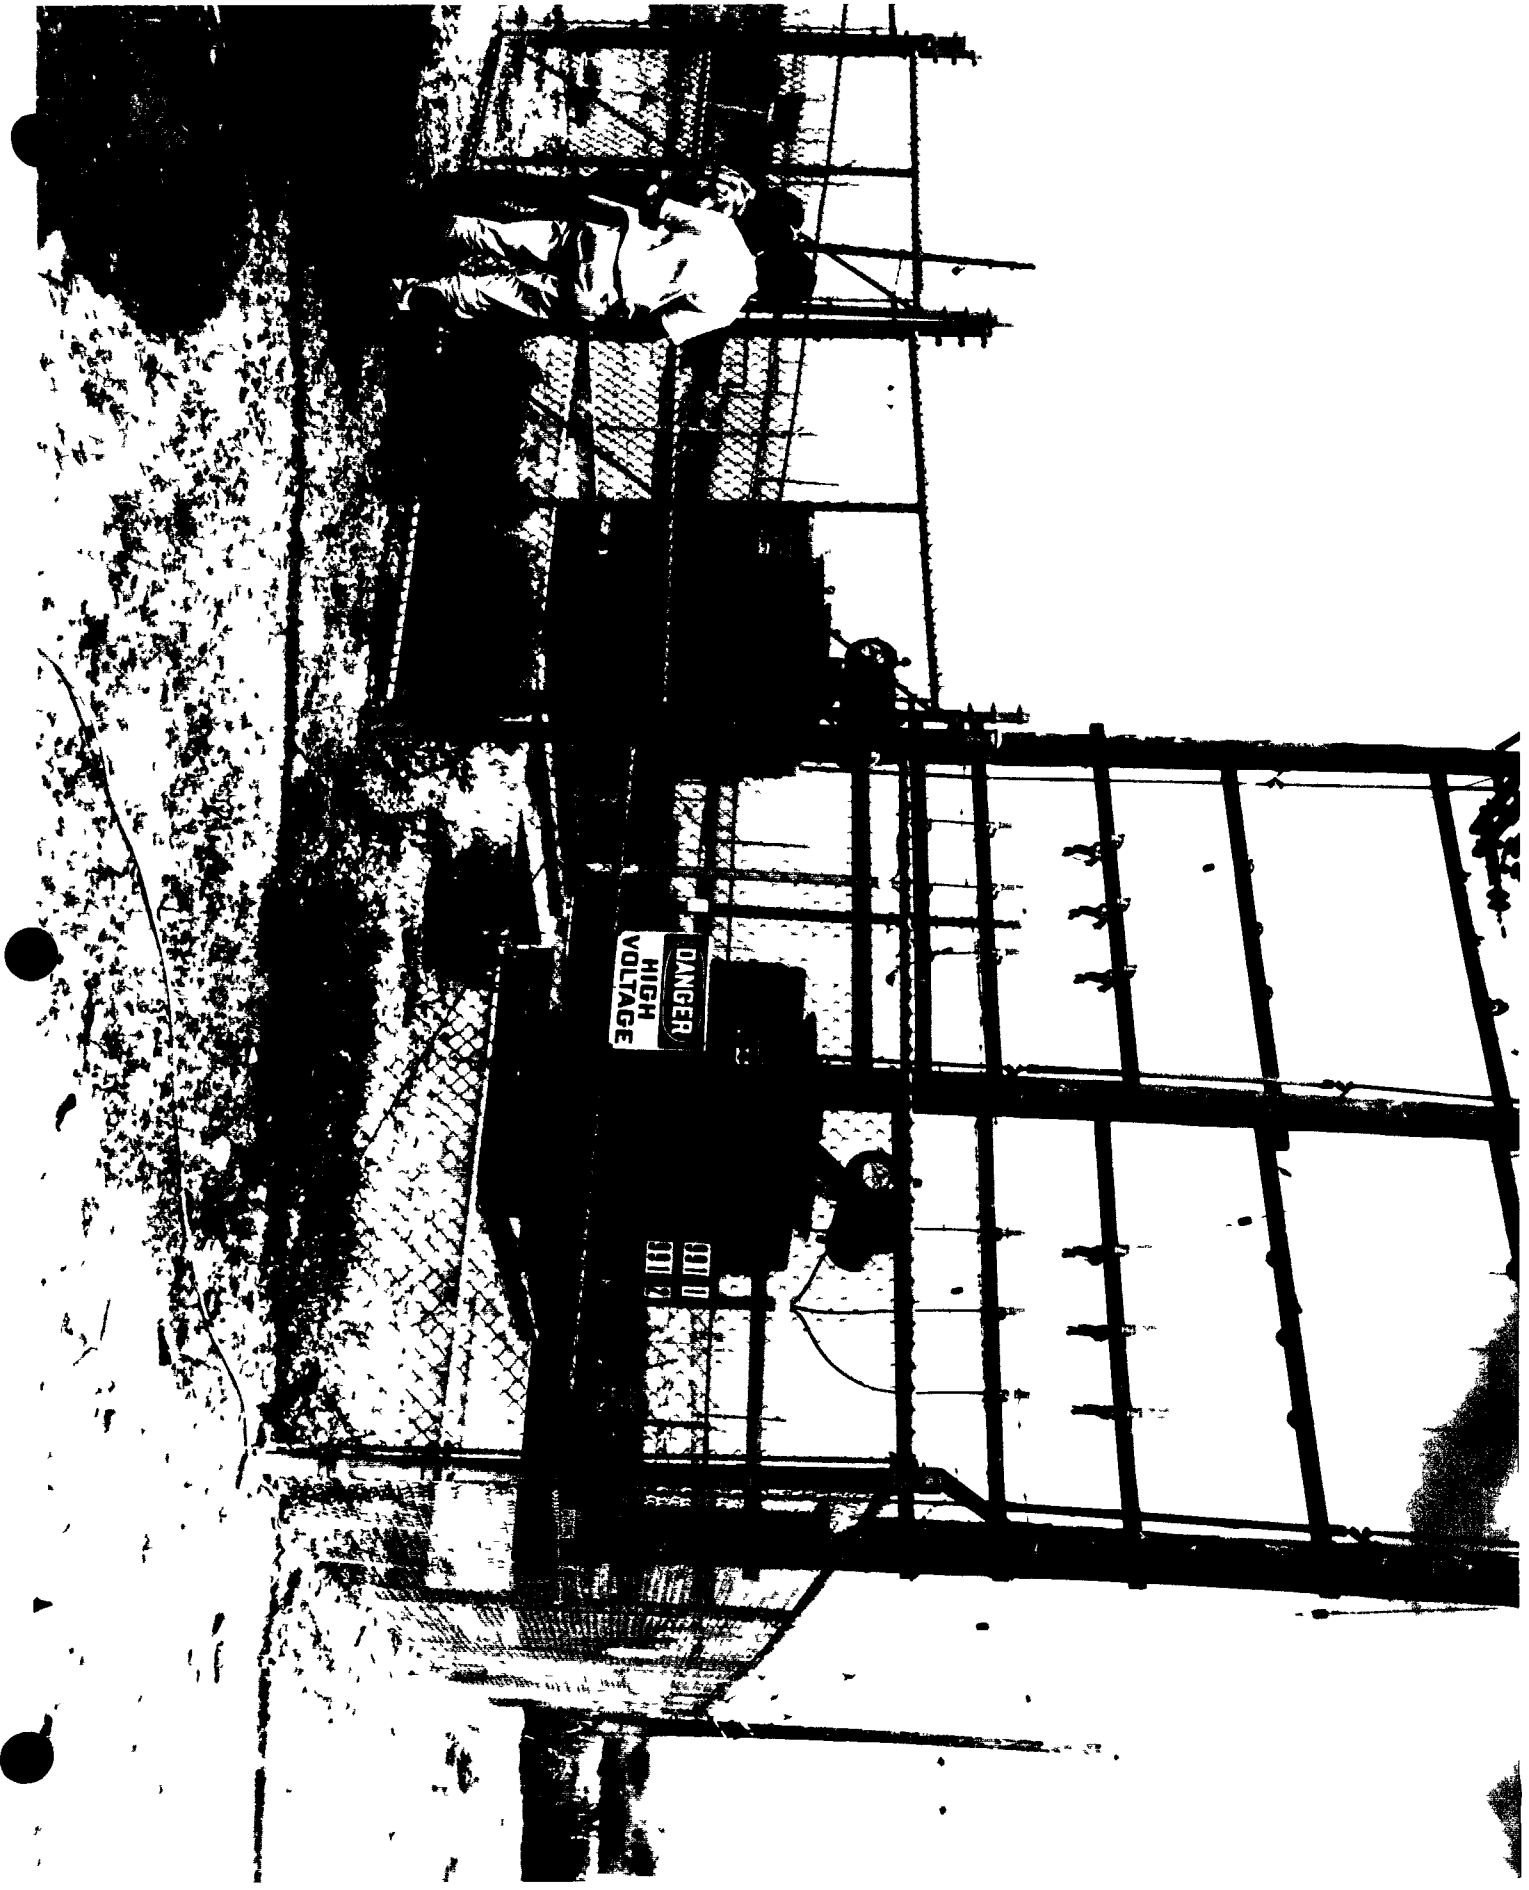
SITE #30 - East of Building 991

EG&G Utilities has documentation indicating that numerous leaks of oil containing PCBs occurred from two transformers located at this site prior to 1987 (Photo #30). The transformers (991-1, 991-2) were retro-filled in 1987. They appear to be leaking at present, as evidenced by the stains on the pads directly beneath the valves attached to the northwest face of the transformers. The site is 26 feet to the east of building 991, adjacent to (IHSS 173) and 80 feet west of IHSS 192. The area is bermed with gravel and stone used as fill.

Site #30 is prioritized as a Category II

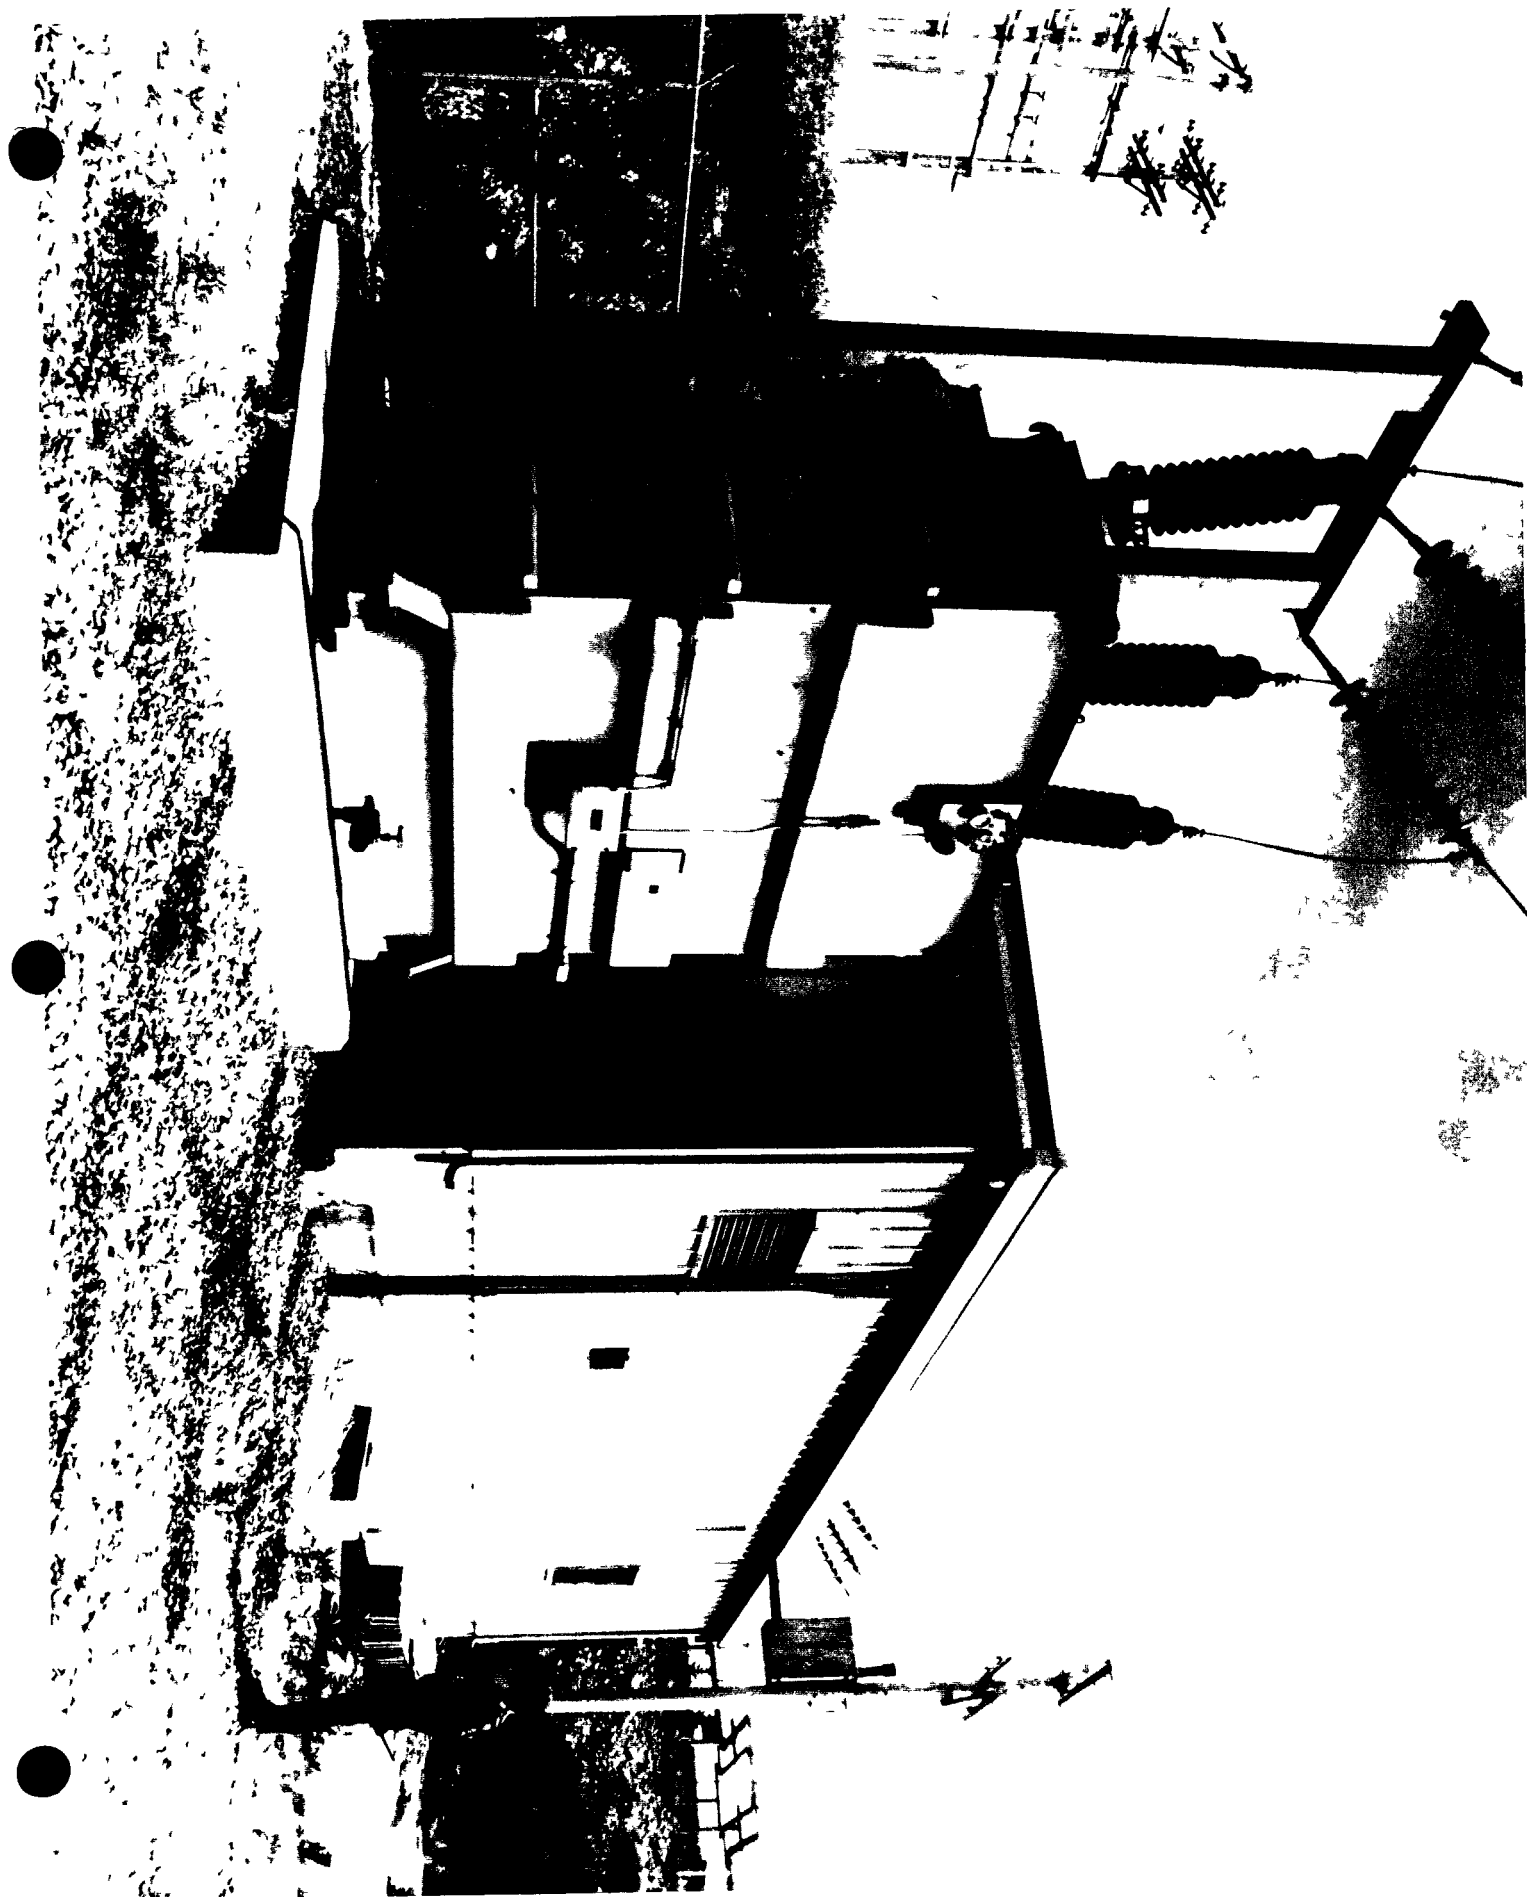
SITE #32 - North of Substation 515-516

Transformer 515 is located within the PA where it is situated on a concrete pad just north of substation 515-516 (Photo #32) It is currently active and there is no evidence of past or present leaking oil The 515 transformer is currently being researched, and little information is available concerning whether it was retro-filled IHSS 117 1 is approximately 400 feet to the southwest There is no berm located at this site There is some rock fill in the area of the transformer

Site #32 is prioritized as a Category III.
